CHRONOLOGY AND CONTEXT OF THE HYATT REGENCY COLLAPSE

By Gregory P. Luth¹

ABSTRACT: This paper presents a brief chronology of the events that preceded the collapse of the walkways at the Kansas City Hyatt Regency Hotel, including the prior failure that occurred during construction and the evolution of the detail that caused the catastrophe. Many of the facts surrounding the case were not publicized, due to the litigation. Some were not brought out during the litigation. No attempt will be made to affix responsibility, as these issues were resolved years ago. The chronology is followed by a discussion of the events that contributed to the collapse and of the changes that have been made in the industry toward preventing a similar occurrence.

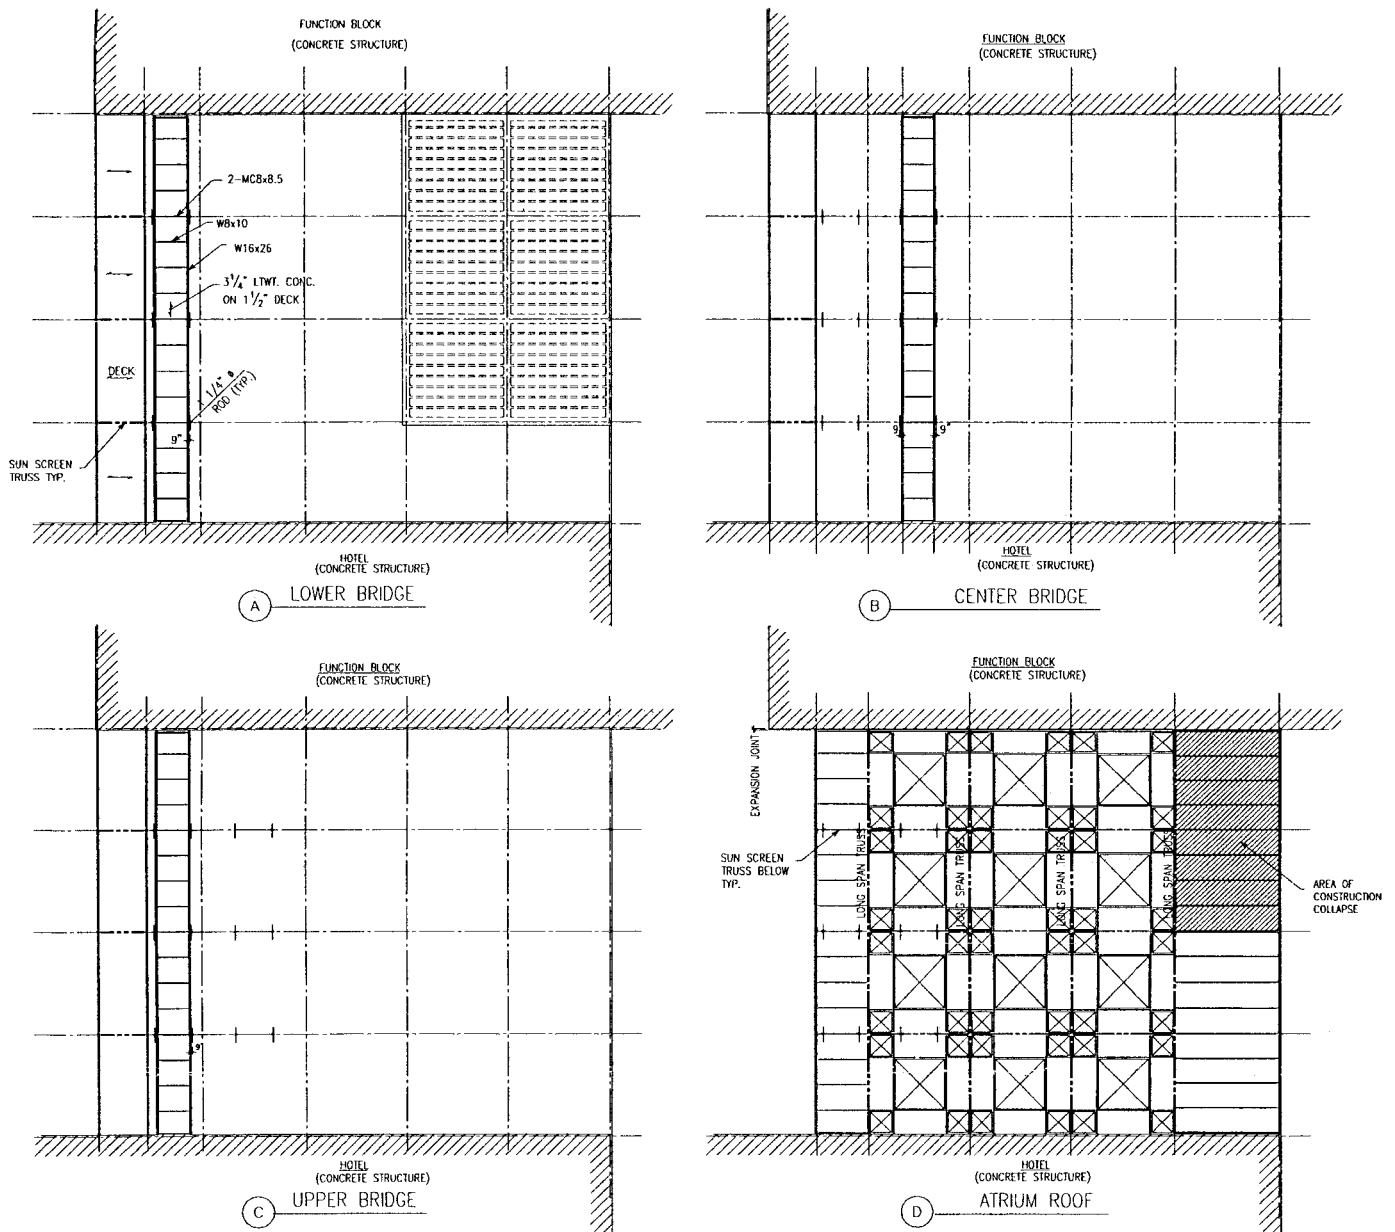
FIG. 1. Floor Plans of Roof and Walkways at Kansas City Hyatt

The detail was cross-referenced at all three floors where the walkways connected to the hanger rods. The dimensions on the plans (Fig. 1) indicated that the hanger rods between the 2nd and 4th floors were in the same location, implying a continuous hanger rod. At the 4th floor the detail was shown as "SIM," indicating in industry shorthand that while there were differences in the details they were the same in all essential respects.

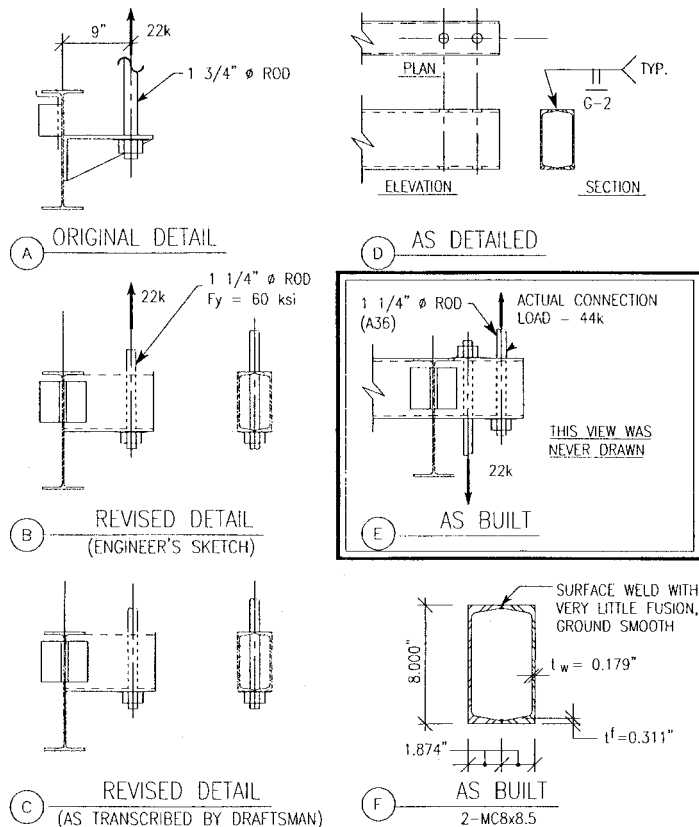
FIG. 3. Evolution of Walkway/Hanger Rod Connection

The draftsman transcribed the detail onto the contract drawings, as shown in Fig. 3(c). Note the information that is missing. Neither the yield strength nor the load is indicated on the detail. The series of events that led to the change in the detail from Fig. 3(a) to Fig. 3(c) were the first steps down the road to tragedy.

The weld symbol on the shop drawings indicated a groove weld between the toes of the channels ground flat. In reality, the dimensions that were used in detailing did not allow for a gap. The shop butted the two flanges together and a surface weld was applied to the outside of the two flanges. A bead was run on the interior of the channels as far back as the welder could reach with his stinger, although this was not explicitly called for on the shop drawings and was not required. The outside weld was ground smooth, leaving a razor-thin sliver of weld metal [Fig. 3(f)].

The as-built connection at the 4th floor bridge is shown in Fig. 3(e). This detail was never drawn, either on the shop drawings or the design drawings. In fact, the connection was never drawn or designed. The engineer assumed that the original single-rod connection would be designed by the fabricator, consistent with the standard practice at the time, for the force indicated on his detail. Because of a drafting error, that force was not on the design drawing. The change to two offset rods had the effect of doubling the connection force from 22 kips to 44 kips.

The change also resulted in two holes through the 100 mm (4 in.) wide box beam. The inner hole isolated the outer hole, limiting the effective length of weld that would be available to resist the concentrated reaction. The fabricator put the upper rod, which had double the reaction, on the outside hole. No stiffeners were provided and no closure plate was provided at the end of the box beam. The holes through the box beam were drilled after welding the two channels together. A standard washer was provided under the nut.

The local failure mechanism was similar at all of the 4th floor connections. Prior to the collapse, the reaction of the rod was carried by the flange of the box beam to the webs. The flange acted as a continuous beam, with both positive and negative moments under the concentrated force from the rod. The weld on the flange bearing on the upper rod ruptured, relieving the midspan moment, forcing the flanges to cantilever off of the 5 mm (3/16 in.) webs. The webs, which were likely in a yielded condition under the self-weight of the bridges, were incapable of resisting the overload; a plastic hinge formed, and the flanges rotated up until the nut and washer slipped through the resulting gap. A similar failure mechanism formed when the upper flange of the box beam hit the nut and washer, although by that time the momentum of the bridge carried it through the failure almost instantaneously.
