CHRONOLOGY AND CONTEXT OF THE HYATT REGENCY COLLAPSE

By Gregory P. Luth¹

ABSTRACT: This paper presents a brief chronology of the events that preceded the collapse of the walkways at the Kansas City Hyatt Regency Hotel, including the prior failure that occurred during construction and the evolution of the detail that caused the catastrophe. Many of the facts surrounding the case were not publicized, due to the litigation. Some were not brought out during the litigation. No attempt will be made to affix responsibility, as these issues were resolved years ago. The chronology is followed by a discussion of the events that contributed to the collapse and of the changes that have been made in the industry toward preventing a similar occurrence.

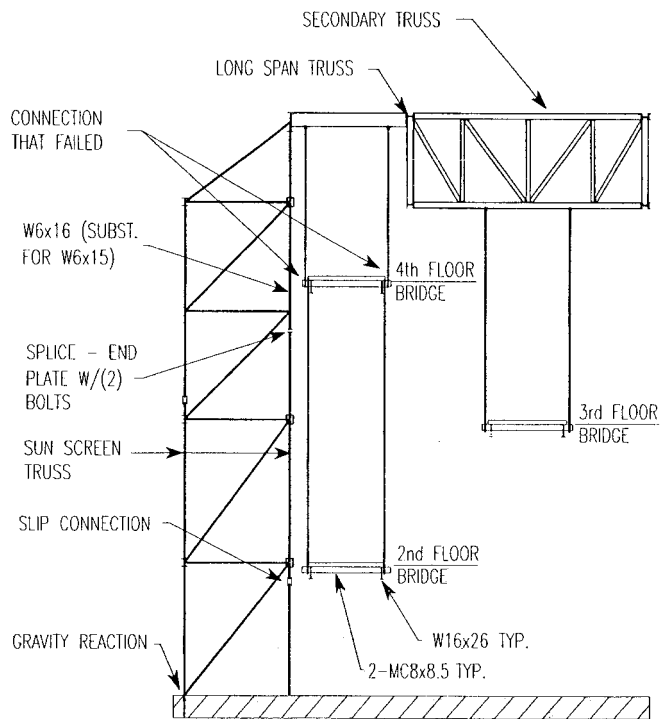
FIG. 2. Section through Bridges

Production of construction documents was ongoing between July 1977 and January 1978. Because of architectural constraints, the sunscreen structure evolved into a vertical truss that picked up loads at the roof on one chord and dropped them off at the first floor at the other chord in order to avoid loading the concrete floor system at the first floor. The inside chord of the sunscreen truss, which functions as a column, was designed to be provided with lateral support by structural tubes that also supported the curtain wall. Early schemes called for the walkways to be supported on posts off of the concrete floor at the first level. Later, the decision was made to suspend the walkways from the roof structure to give a light and airy feel to the atrium space. Fig. 1 shows floor plans of the roof and walkways; Fig. 2 shows a section through the screen wall and bridges.

The detail was cross-referenced at all three floors where the walkways connected to the hanger rods. The dimensions on the plans (Fig. 1) indicated that the hanger rods between the 2nd and 4th floors were in the same location, implying a continuous hanger rod. At the 4th floor the detail was shown as "SIM," indicating in industry shorthand that while there were differences in the details they were the same in all essential respects.
